UNDERWATER BRIDGE INSPECTION REPORT

STRUCTURE NO. 55520
CSAH NO. 12
OVER THE
ZUMBRO RIVER
DISTRICT 6 - OLMSTEAD COUNTY

PREPARED FOR THE
MINNESOTA DEPARTMENT OF TRANSPORTATION
BY
COLLINS ENGINEERS, INC.
JOB NO. 3512 (CEI 151)

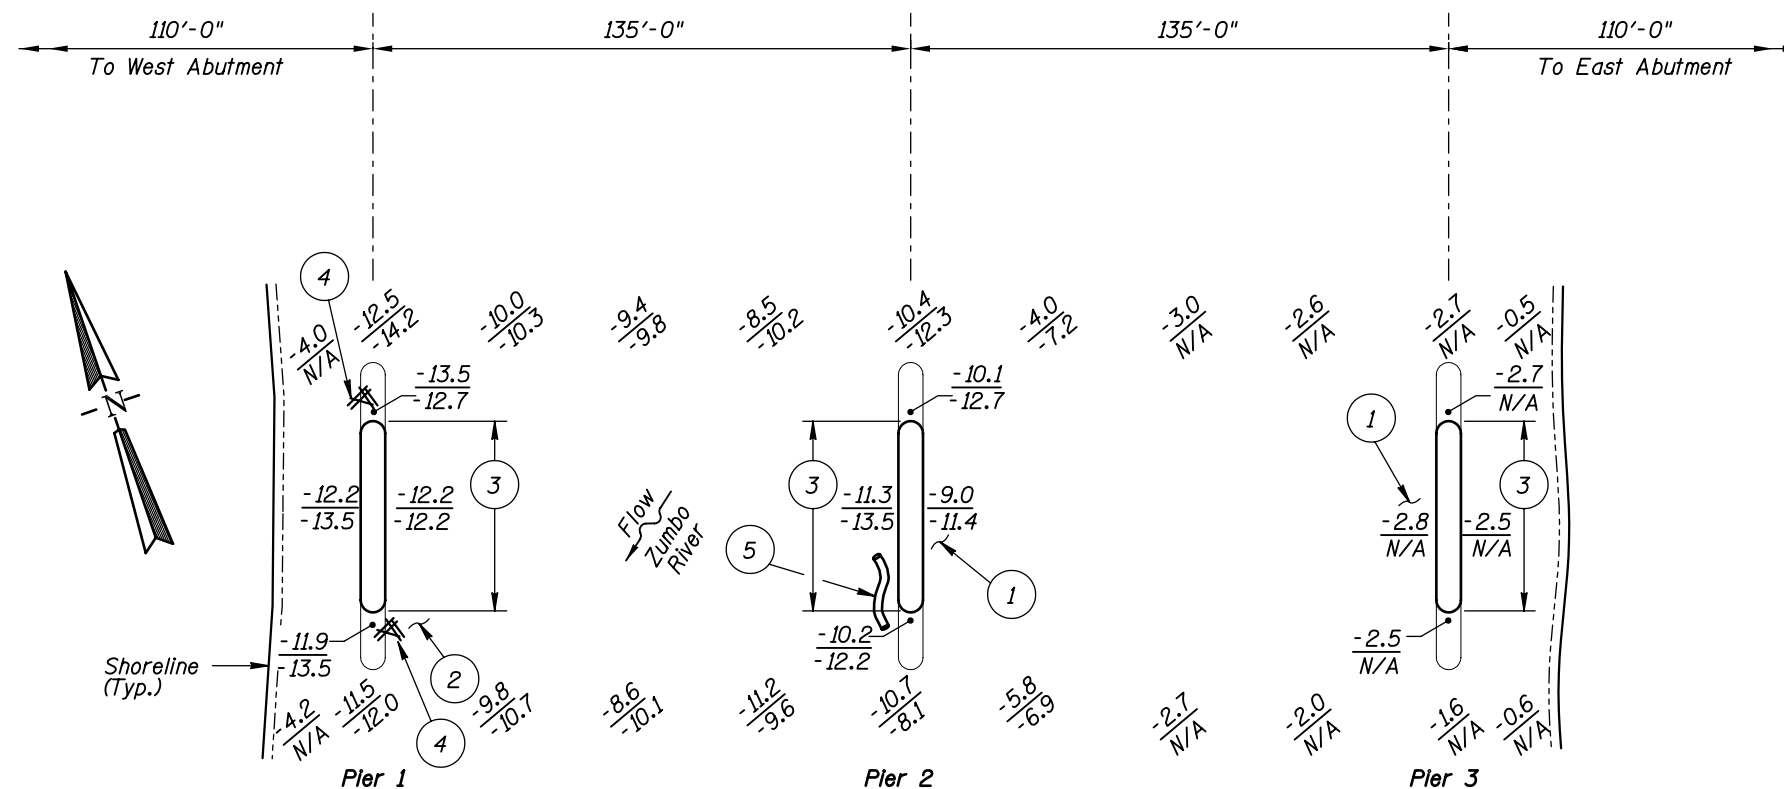
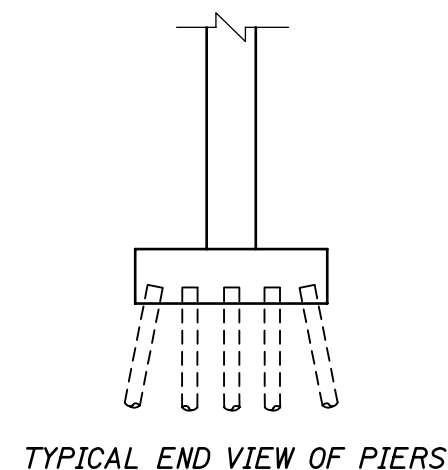
INSPECTION AND SOUNDING PLAN

- The channel bottom consisted of fine silty organics with greater than 2 feet of probe rod penetration.
- The channel bottom consisted of firm material with no probe rod penetration around Pier 1.
- Minor voids due to poor consolidation of the concrete were observed at various locations along piers, typically 1 inch in diameter with 1/2 inch of penetration.
- A light accumulation of 1-foot-diameter and smaller timber debris was observed at both ends of Pier 1.
- A 1-foot-diameter, 15-foot-long log was observed on the channel bottom along the west face of Pier 2.

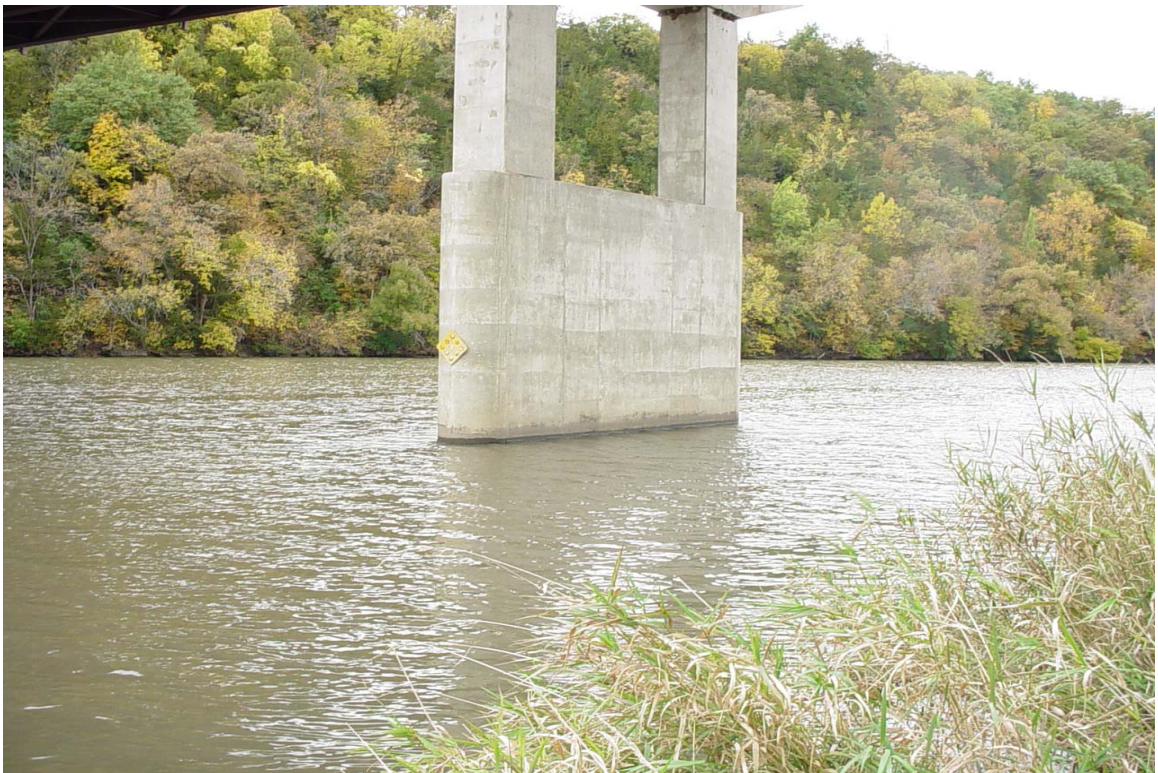
Photograph 2. View of Pier 1, Looking Northwest.

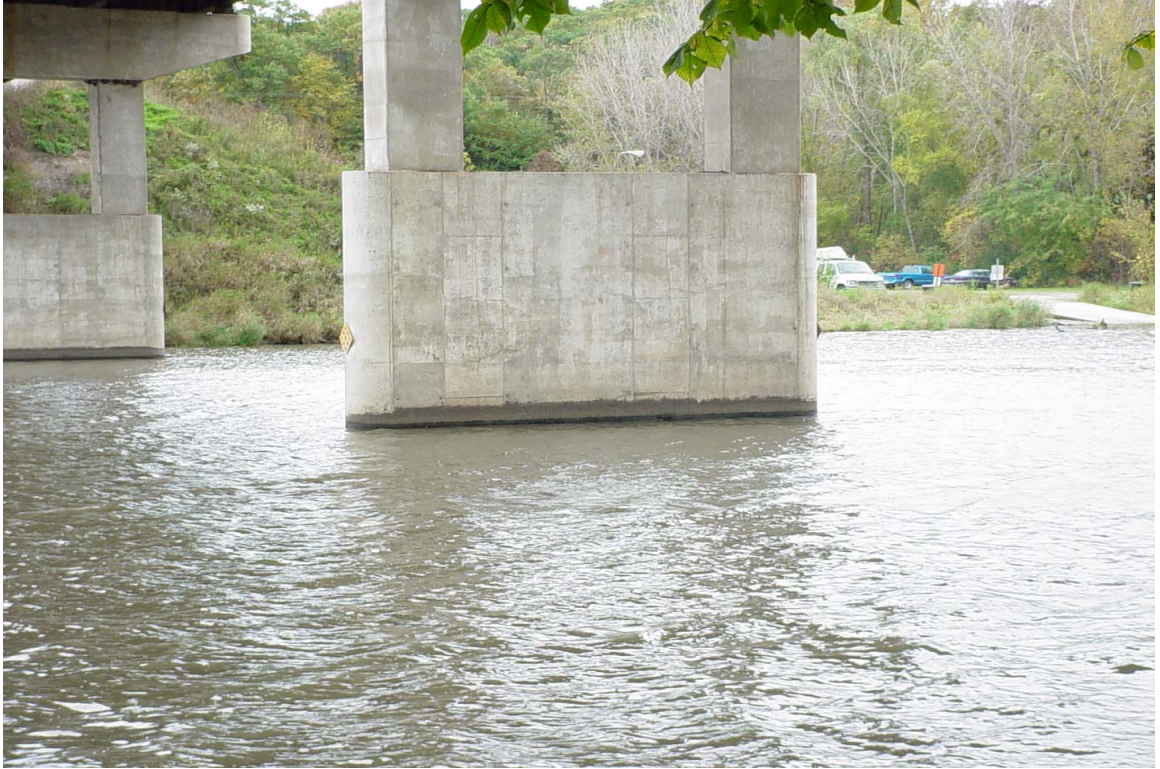
Photograph 3. View of Pier 2, Looking Southeast.

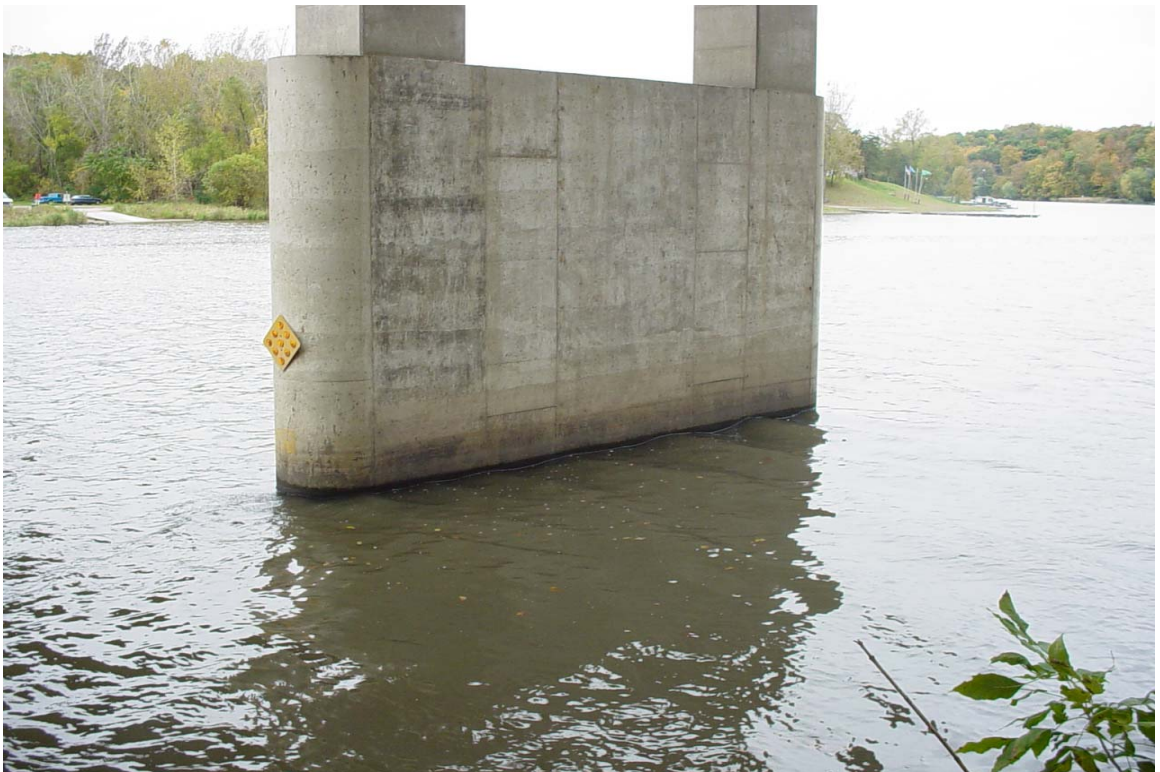
Photograph 4. View of Pier 3, Looking Southeast.
